# **Stop Signal Overrun Investigation**

## **Washington Metropolitan Area Transit Authority (WMATA)**

### **FINAL REPORT**

**August 15, 2016**

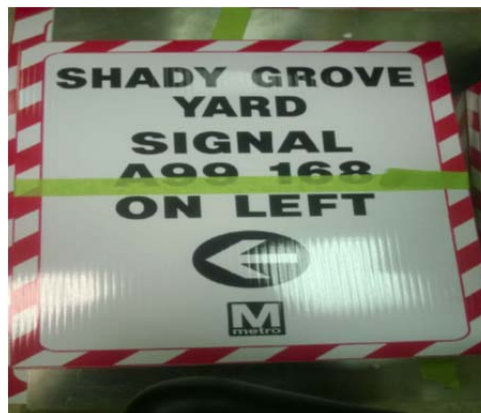
Figure 6: Picture of Installed Signage at Shady Grove Yard

In addition to the added rules, WMATA developed two visual aids for operators. As a result of a stop signal overrun in the Shady Grove Yard in January 2014, WMATA developed a sign notifying train operators of signals placed to the operator's left. WMATA surveyed each yard and installed signage to indicate locations where a signal occurs in that atypical location.

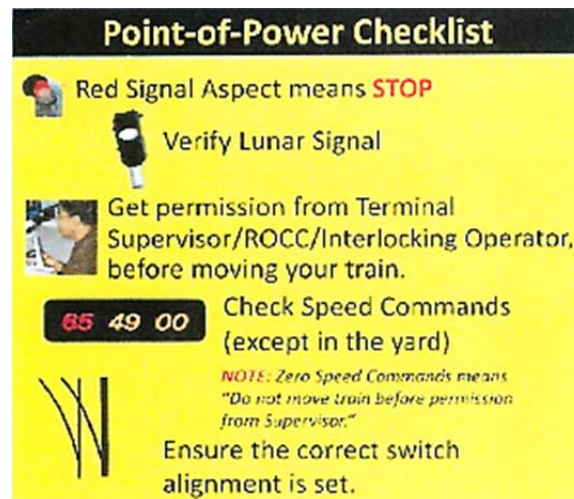
Figure 7: Sticker Installed in Operating Cabs

Following a stop signal overrun at the Van Dorn Street interlocking, and in response to a recommendation in the 2014 stop signal violation report commissioned by WMATA, “point-of-power” stickers have been developed to encourage train operators to focus on five (5) points before moving their trains forward from any stopped position.

These stickers are being placed on the console of WMATA’s train operating cabs, and provide a visual reminder to encourage train operators to verify signals, get permission from the Terminal

Supervisor or ROCC or Interlocking before moving their trains, check their speed commands, and ensure correct switch alignment prior to moving their trains.

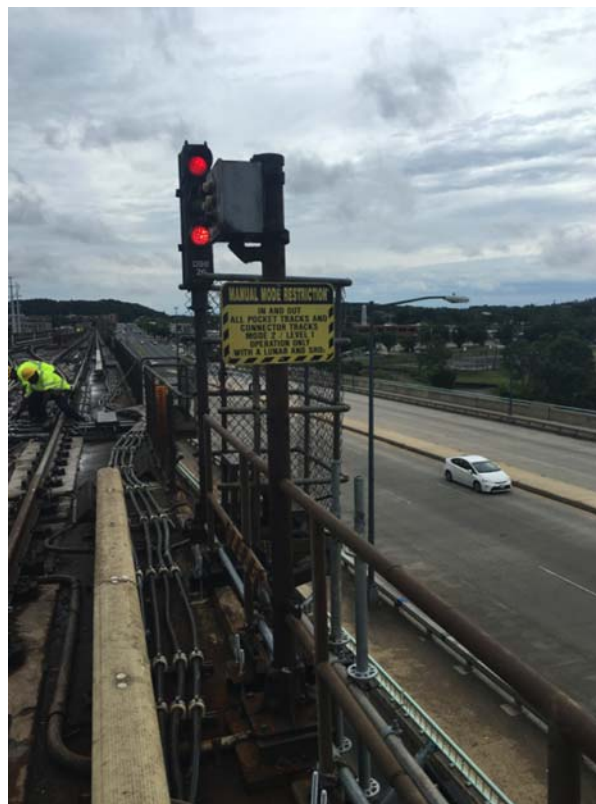
Figure 8: Sign installed near D&G Junction

Also, following a stop signal overrun at a pocket track in 2012, WMATA installed a sign to remind train operators of the manual mode restriction in and out of all pocket tracks and connector tracks.
