Report on Stream Health at Select Tributaries of Rock Creek in Washington, DC

2010-2018

Audubon Naturalist Society
Water Quality Monitoring Program
Cathy Wiss, Program Coordinator

December 2018

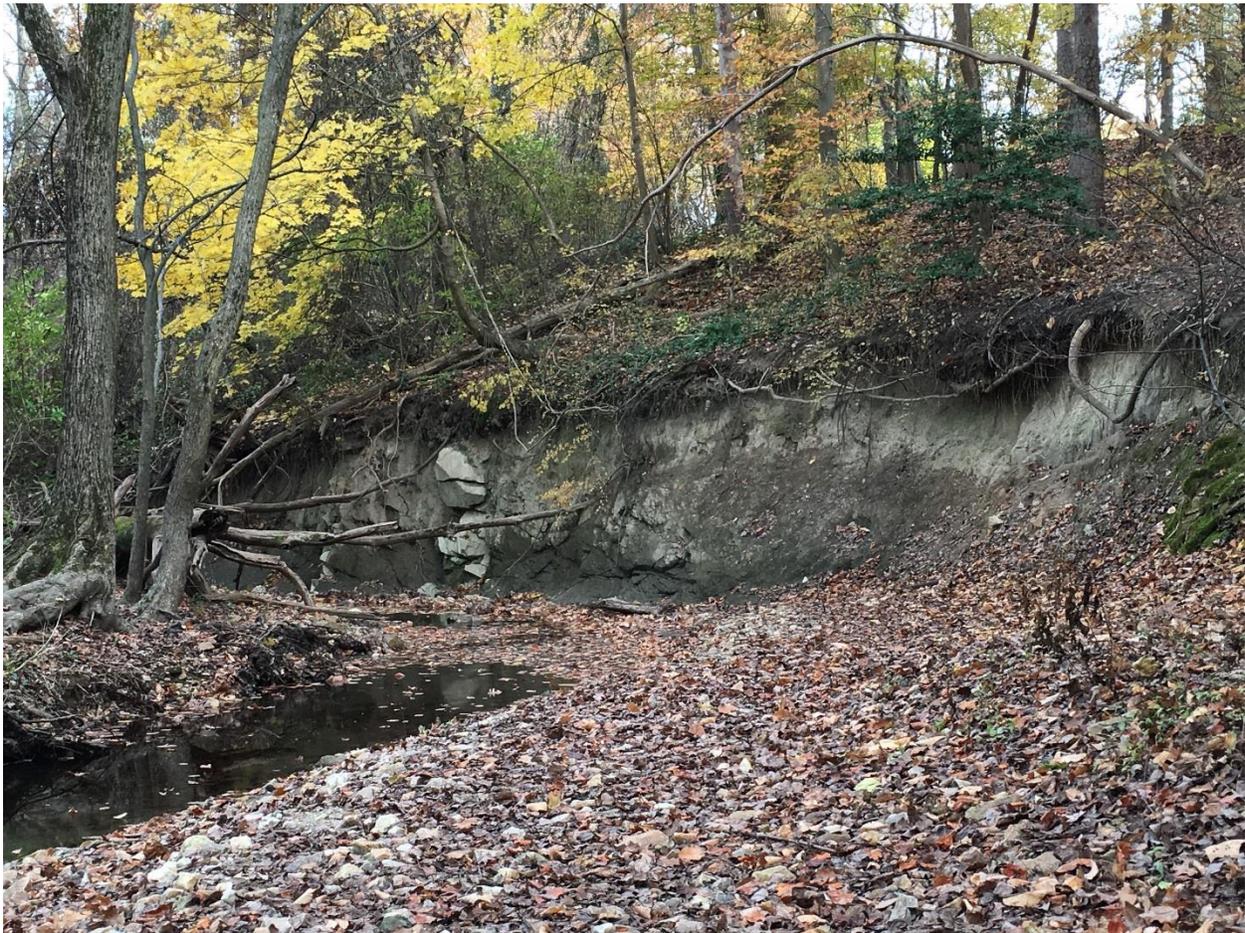
High flows not only erode sediment from the stream valley and stream banks, they undermine and carry away trees. Large amounts of gravel, sand, and tree debris are frequently deposited in the area just upstream of Beach Drive where ANS monitors. In between high flows, the ANS monitoring team frequently reports periods of low base flow.

Figure 2: Bank erosion at Pinehurst Branch. Photo credit: Cathy Wiss.

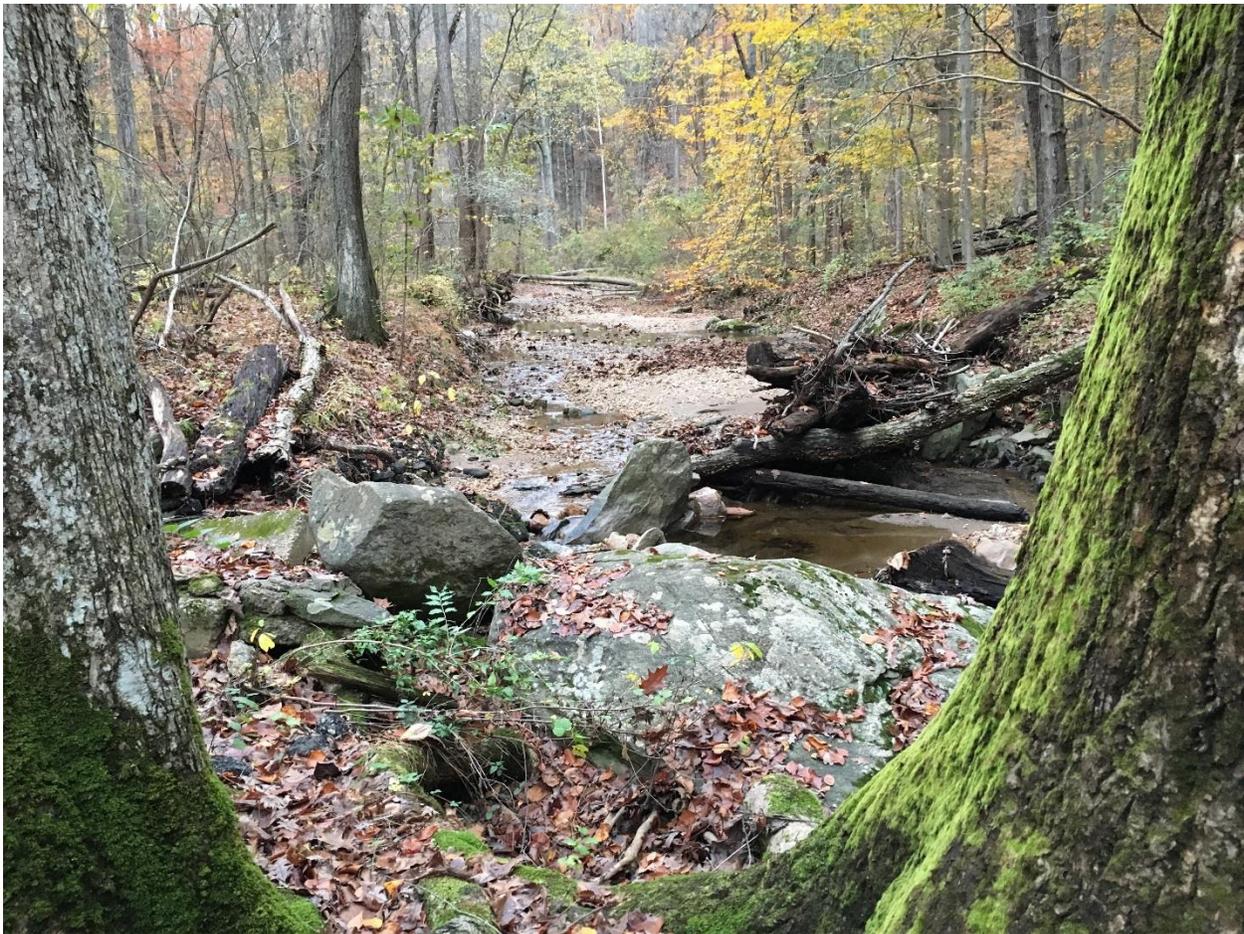
Figure 3: Pinehurst Branch monitoring site. Photo credit: Cathy Wiss.

The ANS monitoring site is in the lower section of Pinehurst Branch within a hilly wooded area of Rock Creek Park east of Oregon Avenue, NW. It is located not far from where Pinehurst Branch enters Rock Creek. A foot trail parallels the stream from Rock Creek to Western Avenue. Another foot/horse trail crosses the stream within the ANS monitoring reach.

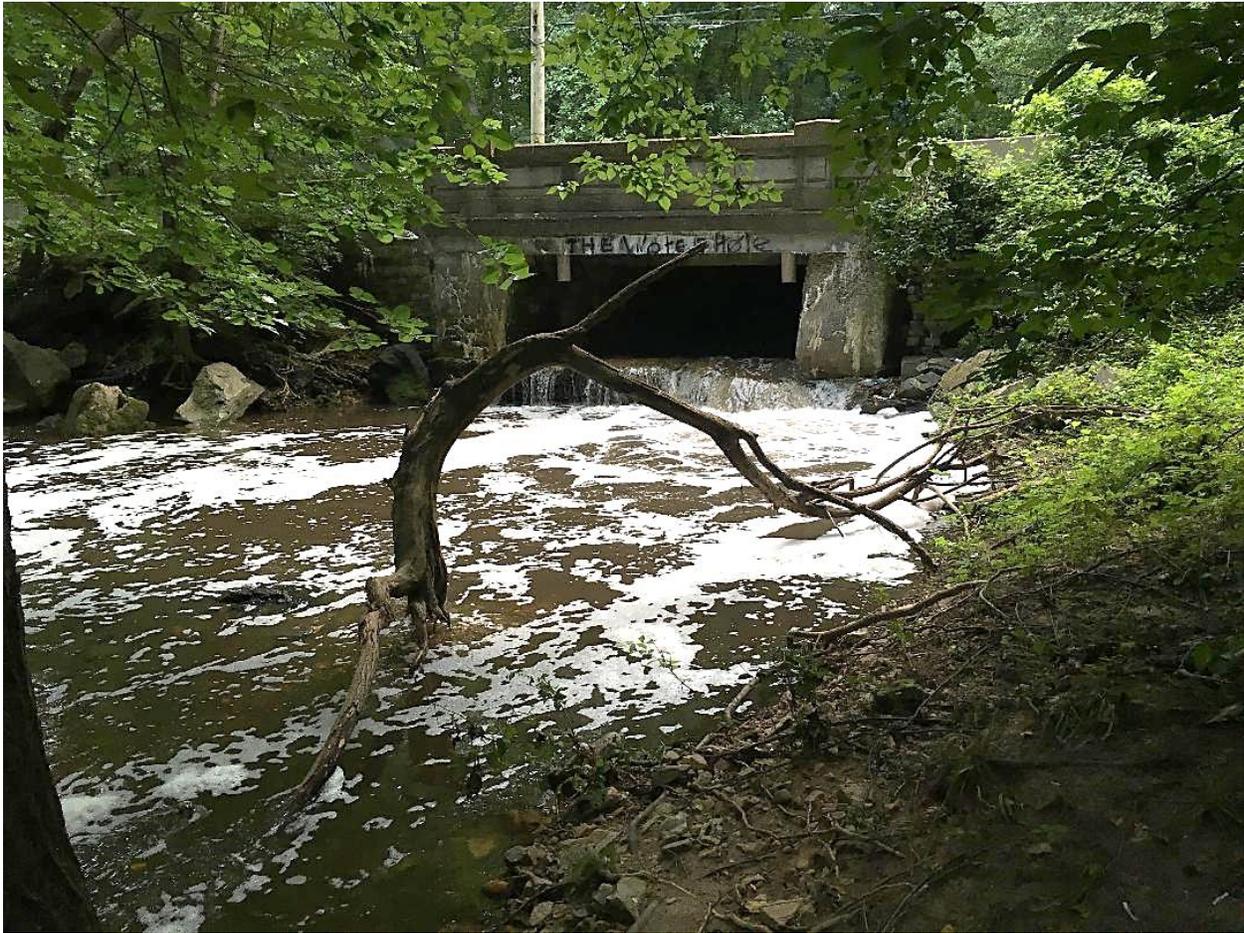
After a thunderstorm on July 3, 2018, suds could be seen in the water downstream of the Oregon Avenue bridge. These may have come from residues on the road surface, a sanitary sewer leak, an improper sanitary connection to the stormwater system, or someone washing a car or heavy construction equipment nearby. Suds were again observed near the Western Avenue outfall that brings stormwater from Chevy Chase, Maryland, on a dry day in fall 2018. Water below the outfall was a milky blue, suggesting an improper sanitary sewer connection to the storm sewer system. We recommend continued monitoring for this type of discharge in order to determine its source and take corrective action.

Figure 4: Suds below the Oregon Avenue bridge on Pinehurst Branch, July 3, 2018. Photo credit: Cathy Wiss.

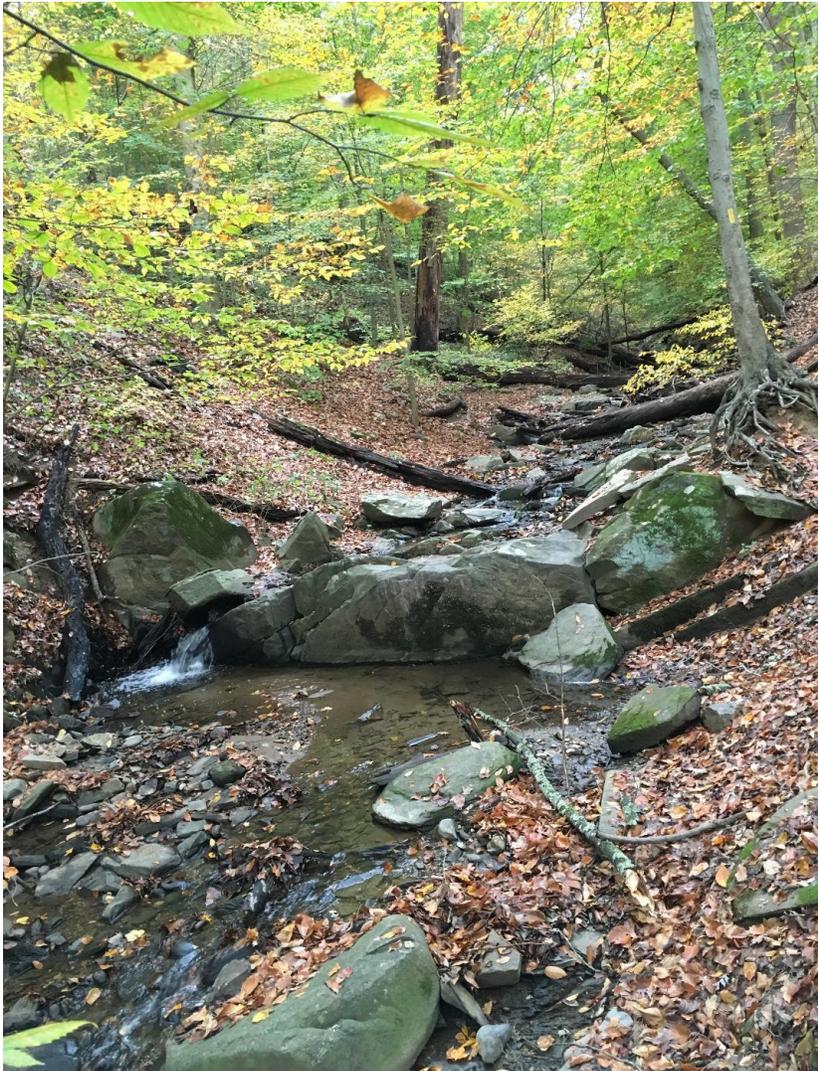
East of the Springland Farm community the stream flows through Melvin C. Hazen Park. Before reaching Connecticut Avenue, water is slowed by having to pass through a narrow pipe culvert under a parking lot and the avenue. Constricted by the culvert, the stream backs up and spreads out onto a broad floodplain, forming a pond. This allows groundwater recharge and slow percolation through the pipe. Ducks frequently are seen on the pond.

Figure 5: Melvin Hazen Run. Photo credit: Cathy Wiss.

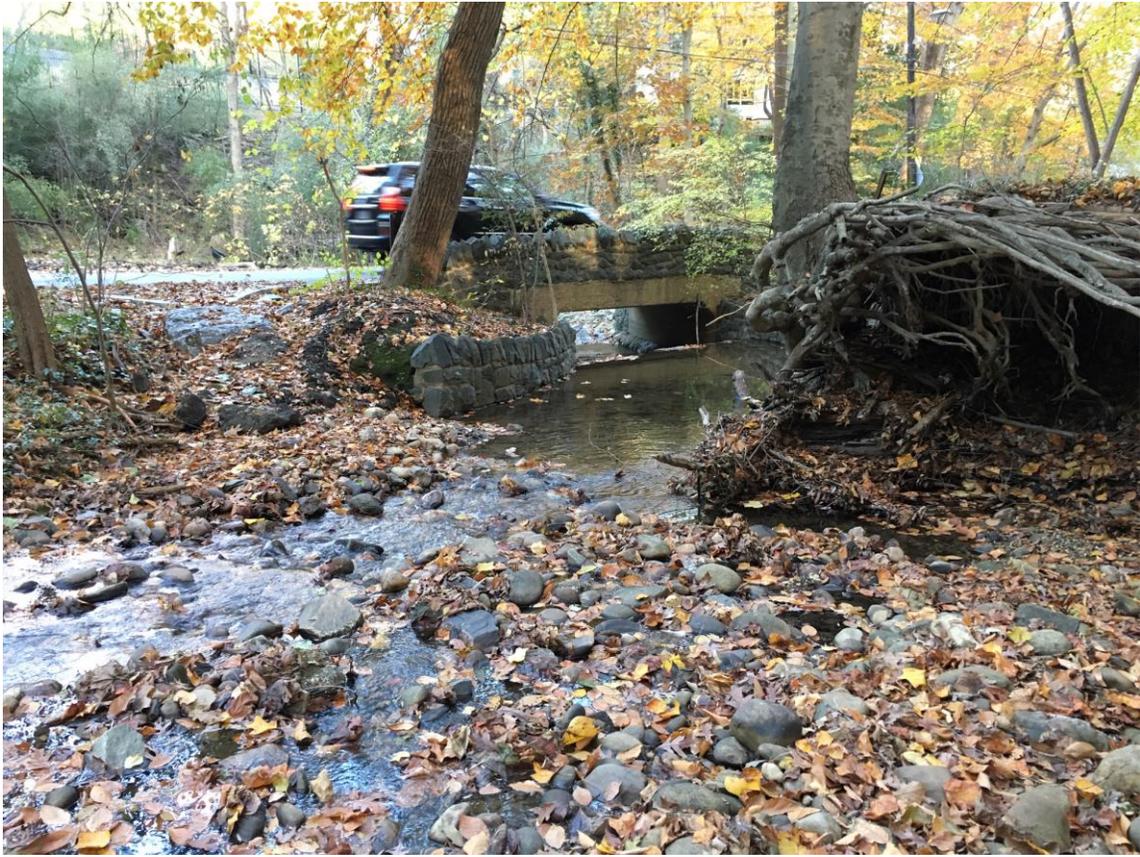
Figure 7: Normanstone Run monitoring site and bridge. Photo credit: Cathy Wiss.

In 2010, the ANS monitoring team started noticing a sewage smell from the stormwater outfall at the upstream end of their reach. They described seeing a dark sediment on the rocks and an oily sheen on the water. They continued to notice a sewage smell and dry weather flow of gray soapy water from the culvert. In 2012, the ANS team reported the problem to the National Park Service. DC Water determined that an overflow pipe at a sewage lift station on the Naval Observatory property had been improperly connected to the storm sewer. Although the problem was corrected, the team has continued to notice gray, odorous dry weather discharge from the stormwater outfall as recently as November 12, 2018. That flow, shown in Figure 7, lasted 25 minutes.

In 2011, riprap was installed on both banks and the streambed of Normanstone Run by the bridge where our team monitors. Runoff is still so heavy, though, that some of the riprap has washed downstream. Although **DDOT's current project to install bioretention ponds and bio-swales along Normanstone Drive and Fulton Street, NW, may well reduce runoff and flooding, new spillways from the bridges and roads will channel some runoff directly into the stream without any treatment for pollutants like oils and road salt.**

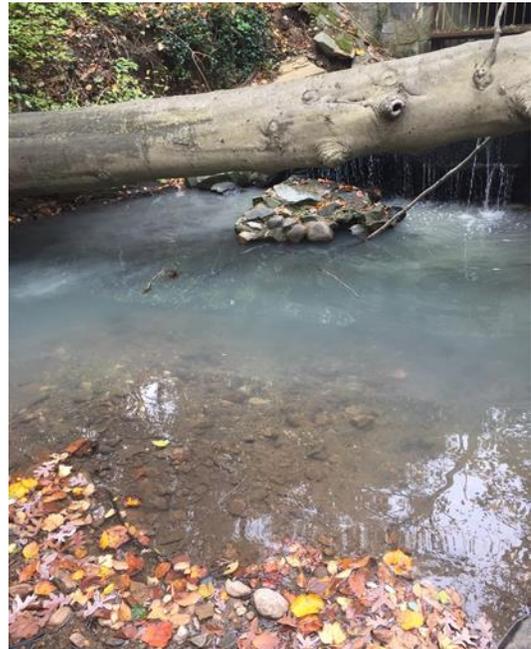
Figure 6: Illicit discharge at Normanstone Run. Photo credit: Mike Kolian.

Yet improper connection of sanitary sewer service to stormwater pipes does occur, as we have found at Normanstone Run and most likely at Pinehurst Branch. In 2012, the Normanstone team's observance of dry weather flow from a stormwater outfall led to the discovery and correction of an improper sanitary sewer hookup at the Naval Observatory. In fall 2018, odorous gray dry weather discharge was again flowing from the same stormwater outfall. Likewise, suds have been observed on Pinehurst Branch, and the pool below the Western Avenue outfall was an uncharacteristic milky blue on a dry day in fall 2018. **We request that DC Water, DOEE, and the Washington Suburban Sanitary Commission (WSSC) seek the sources of these illicit discharges and ensure that they are corrected.**

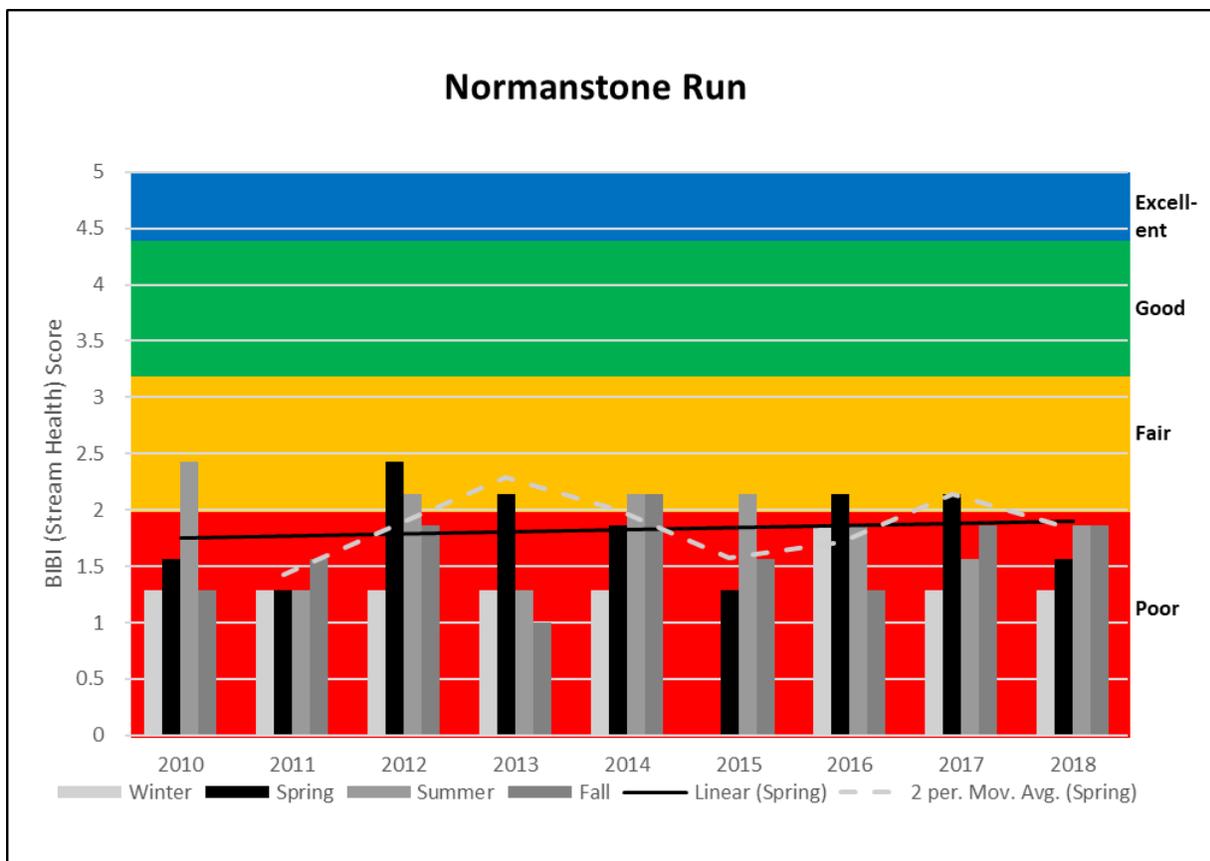
In fact, in most years from 2010-2018, Normanstone Run had at least one monitoring season in which water quality exceeded a BIBI score of 2.00. In general, stream health of Normanstone Run has improved over time. Team leader Mike Kolian analyzed the occurrence of the ten most commonly found macroinvertebrates from 1997-2016. He found that in recent years, the proportion of mayflies and caddisflies in the samples has increased.¹³

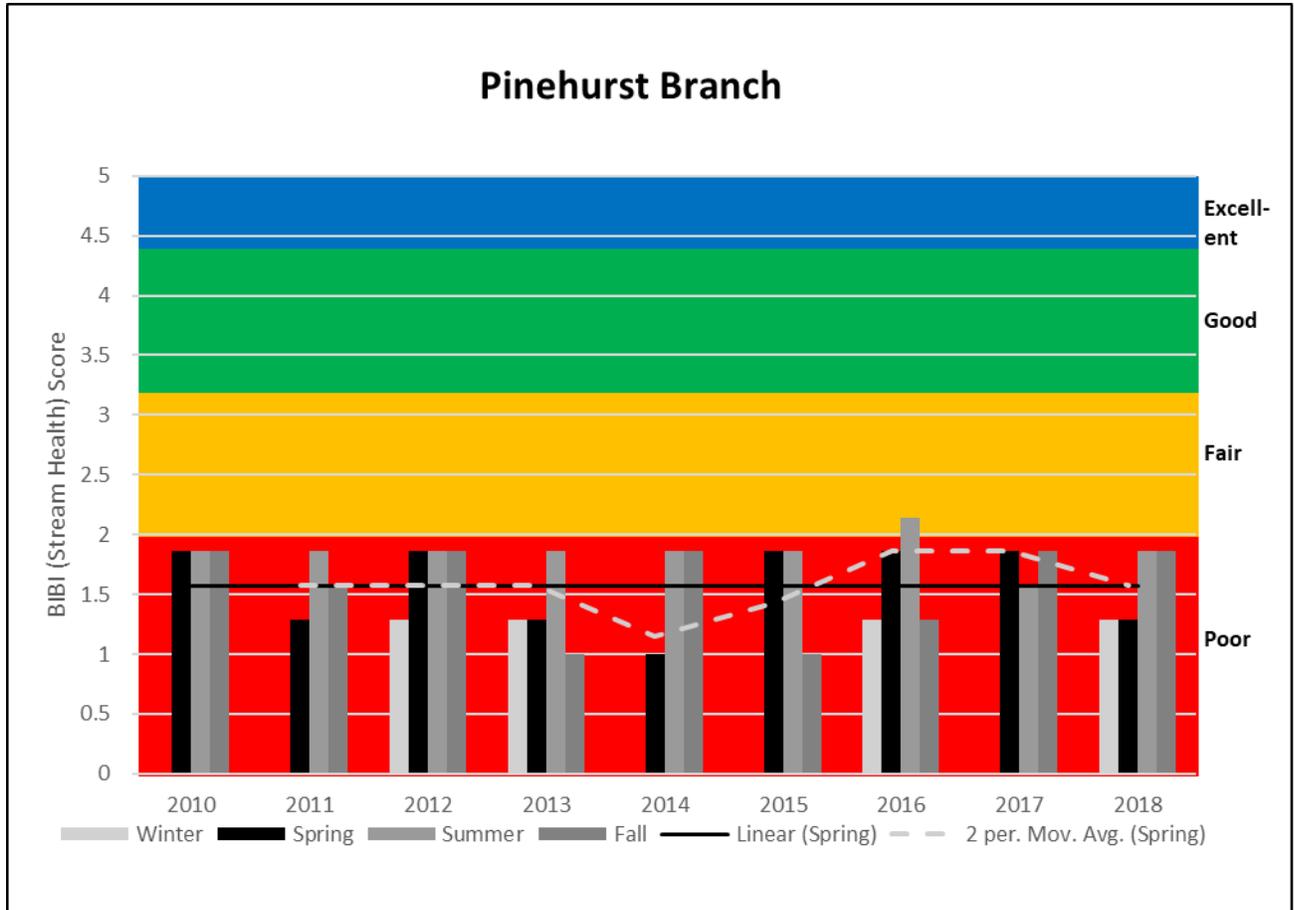
Stream health at Pinehurst Branch has been poor but stable, fluctuating just above and just below the NPS average of 1.50. Samples with high percentages of small minnow mayflies (*Baetidae*) led to higher BIBI scores.

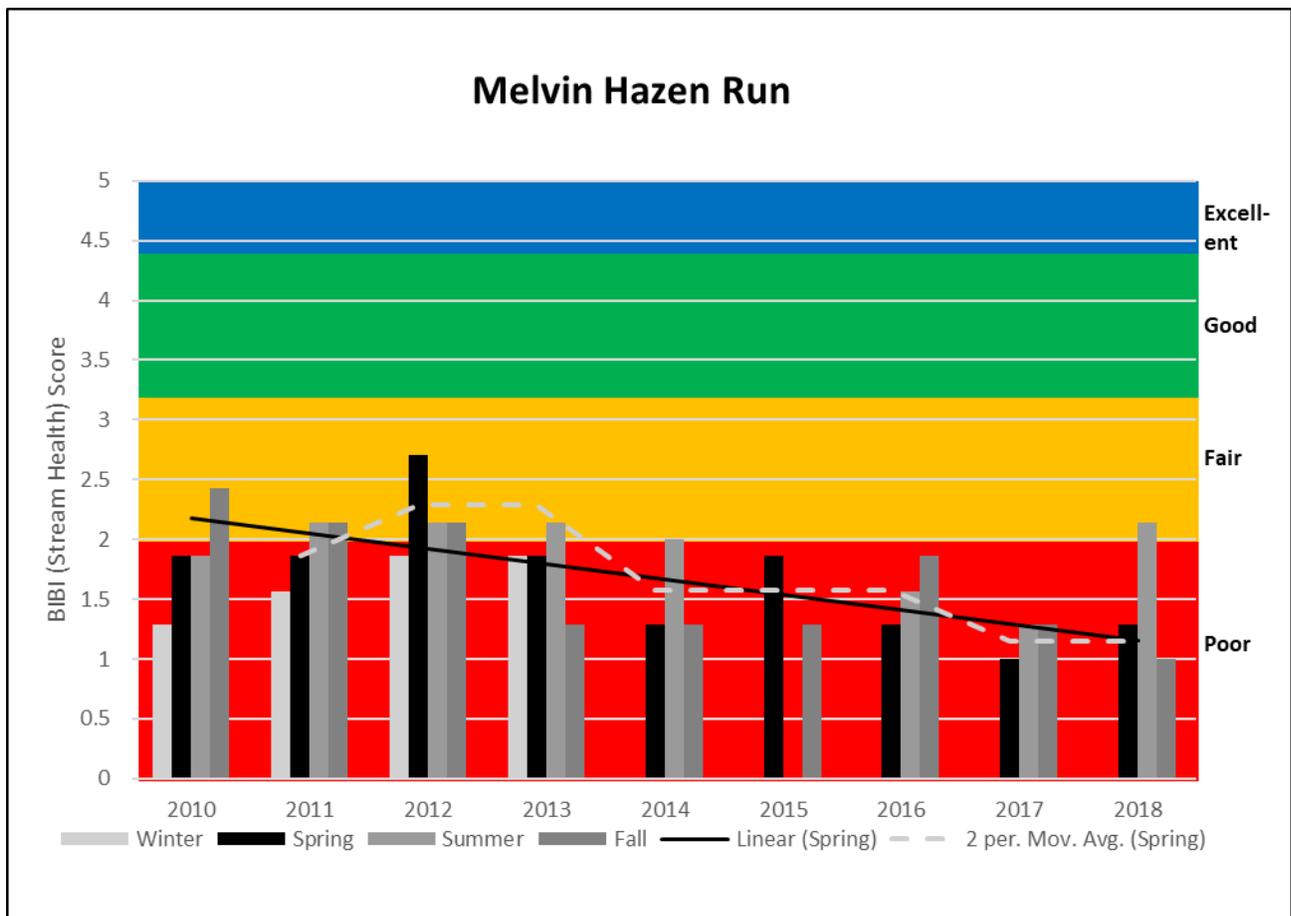
But Melvin Hazen Run is in clear decline: In 1987, the District sampled Melvin Hazen Run (chart on next page) and rated it one of the best streams in the area, with a balanced aquatic community and fair to good water quality.¹⁴ Melvin Hazen Run continued to improve after ANS started monitoring in 1997. The macroinvertebrate population at Melvin Hazen Run was especially diverse from 2005-2009, when 10-16 different families were often collected during a site visit, as well as a high percentage of mayflies. The average BIBI score for these years was 2.20. Yet, stream health has declined since 2010. Now, fewer families are being found, and mayflies make up a smaller percentage of the sample. Loss of diversity and sensitive taxa in recent years is evident.
