# **Stop Signal Overrun Investigation**

## **Washington Metropolitan Area Transit Authority (WMATA)**

### **FINAL REPORT**

**August 15, 2016**

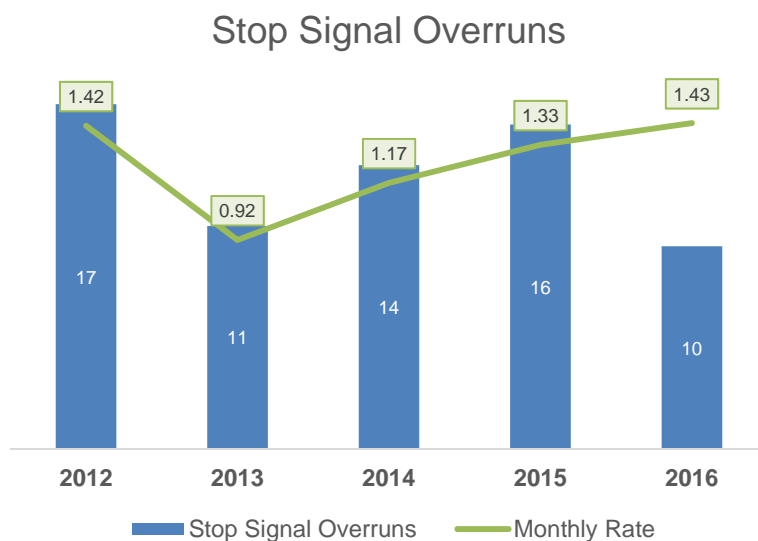
Figure 1: WMATA Stop Signal Overruns and Rate by Year, 2012 through July 31, 2016

Figure 1 presents the number of stop signal overruns by year and the average monthly rate of occurrence. WMATA experienced more stop signal overruns in 2015 than in either of the two previous years. Through July 31, 2016, WMATA averages 1.43 stop signal overruns per month, its highest average rate since 2012. With 10 stop signal overruns so far in 2016, WMATA is on pace to match or exceed the 2015 stop signal overrun total.

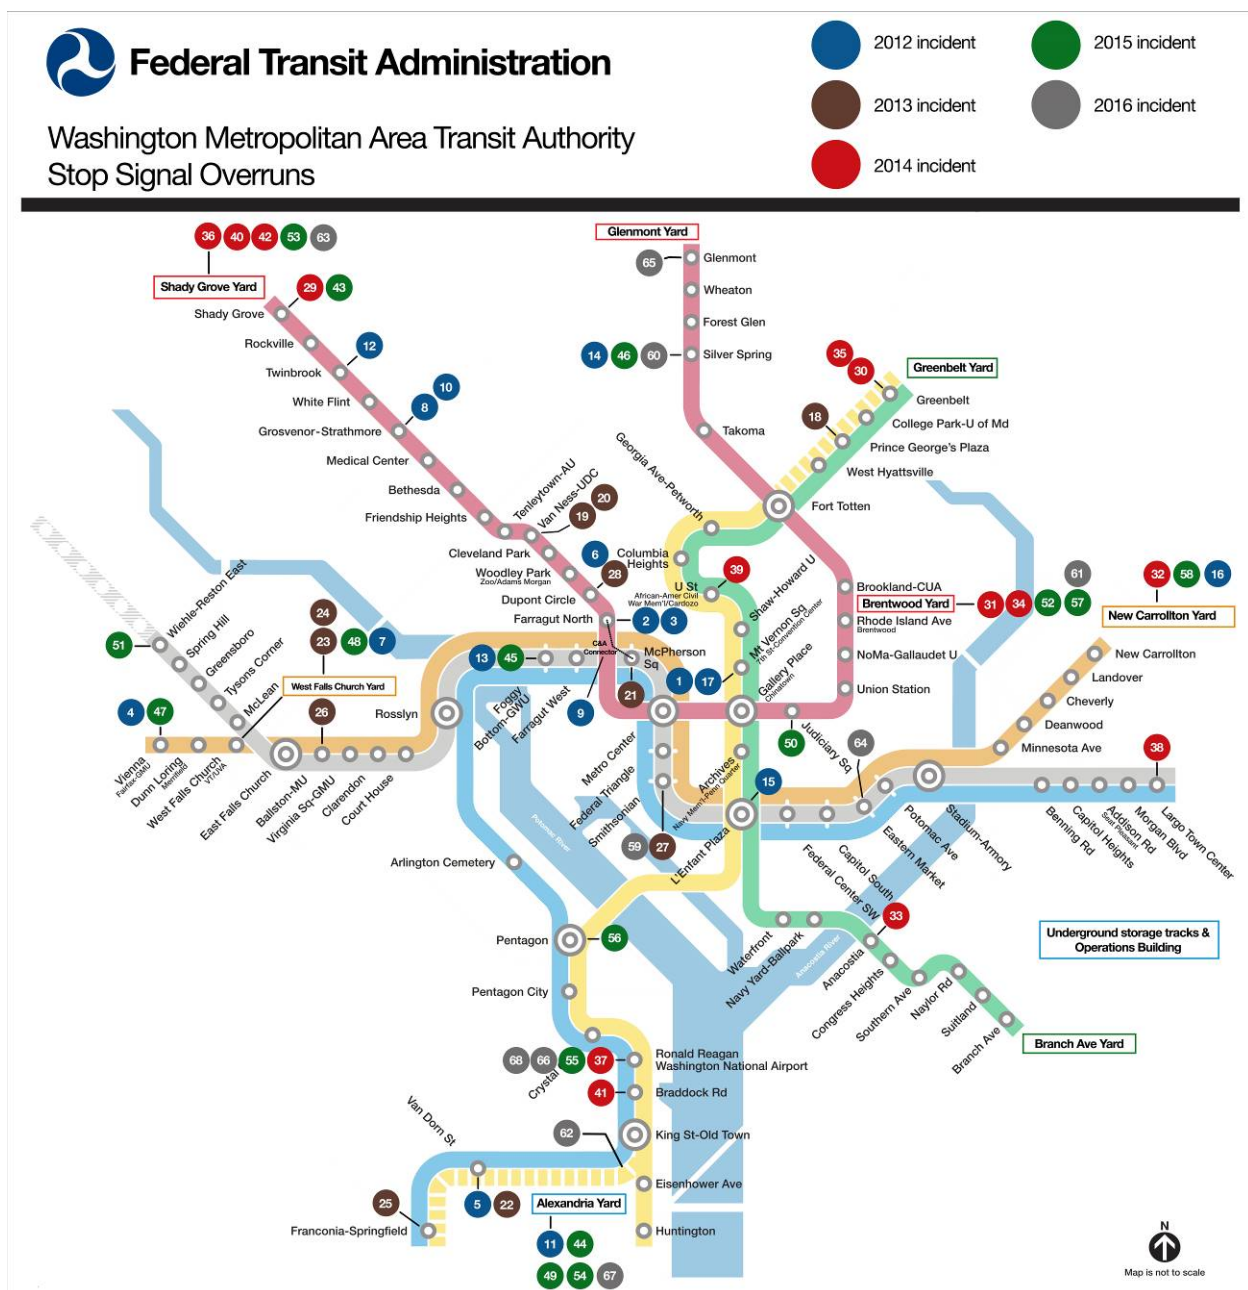
Figure 2: WMATA Stop Signal Overruns and Rate by Location and Year, 2012 through July 31, 2016

Figure 2 identifies the location of all stop signal overruns on the WMATA Metrorail system by year.

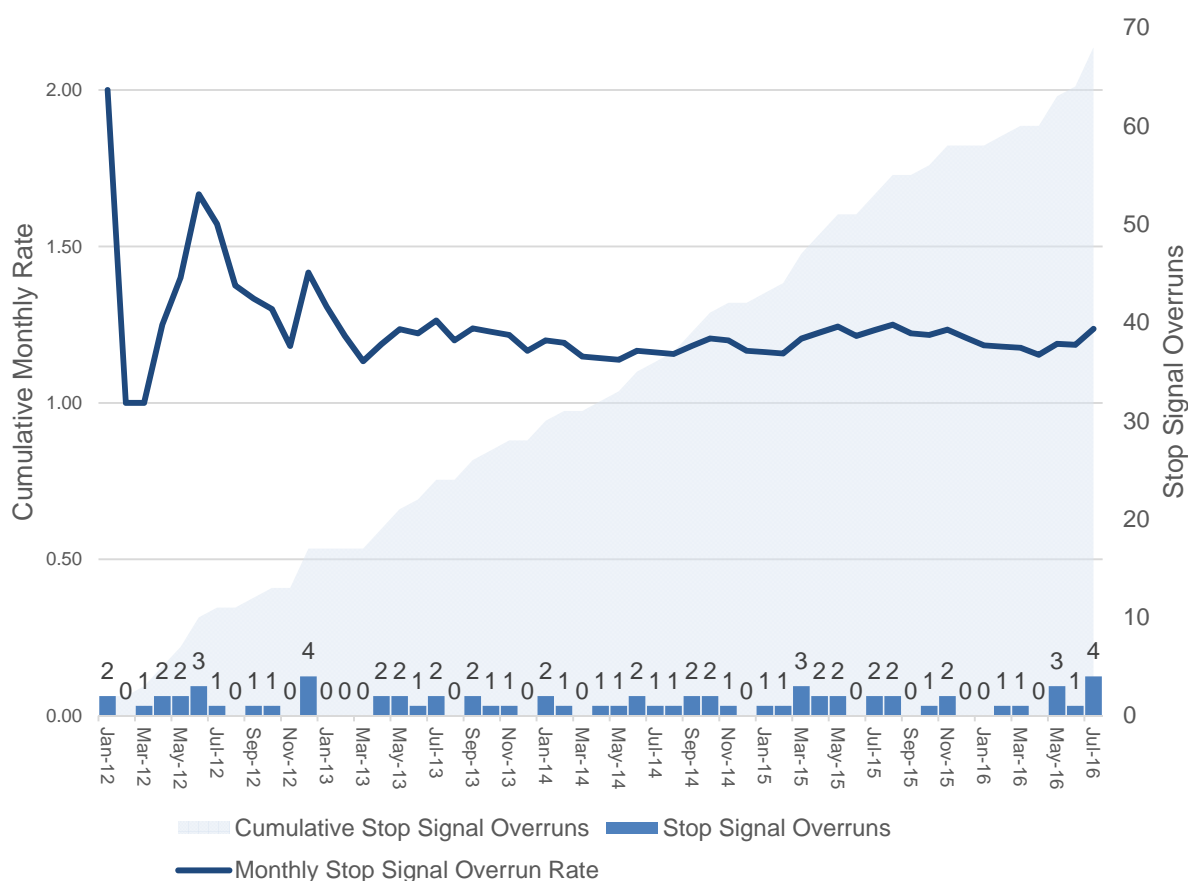
Figure 3: WMATA Stop Signal Overruns Cumulative Rate by Month

Figure 3 presents the number of stop signal overruns by month and the cumulative monthly rate since January 1, 2012. The cumulative monthly rate refers to the monthly rate for the period from January 2012 to that month, which is determined by the dividing the number of stop signal overruns by the number of months for the period. Figure 3 illustrates the relative consistency of the occurrence of stop signal overruns on the Metrorail system. The data presented in this figure shows that longest period between stop signal overruns has been 97 days, and the shortest period, one day. Over the 55-month period, WMATA experienced 2 months with 4 stop signal overruns (the highest number), 3 months with 3 stop signal overruns, 16 months with 2 stop signal overruns, 19 months with one stop signal overrun, and 15 months with no stop signal overruns.
